CLEAN WATER ACT
COMPLIANCE INSPECTION

(For EPA Purposes Only – [REDACTED] CAFO)

On-Site June 16, 2011

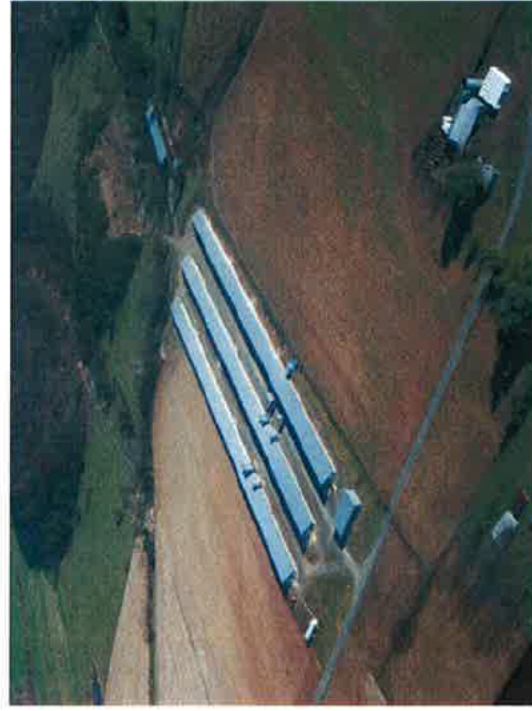
2010-11-09--14.39.10

On November 9, 2010, Mahri Monson and Rebecca Crane of the United States Environmental Protection Agency (EPA) conducted a fly-over reconnaissance inspection of the poultry operation located on [REDACTED] Road (the "Facility"). Photographs were taken in the area of the Facility and are attached (see Appendix A). Of those pictures in the area, the following show all or portions of the Facility: 2010-11-09--14.39.10, 2010-11-09--14.39.16, and 2010-11-09--14.39.25.

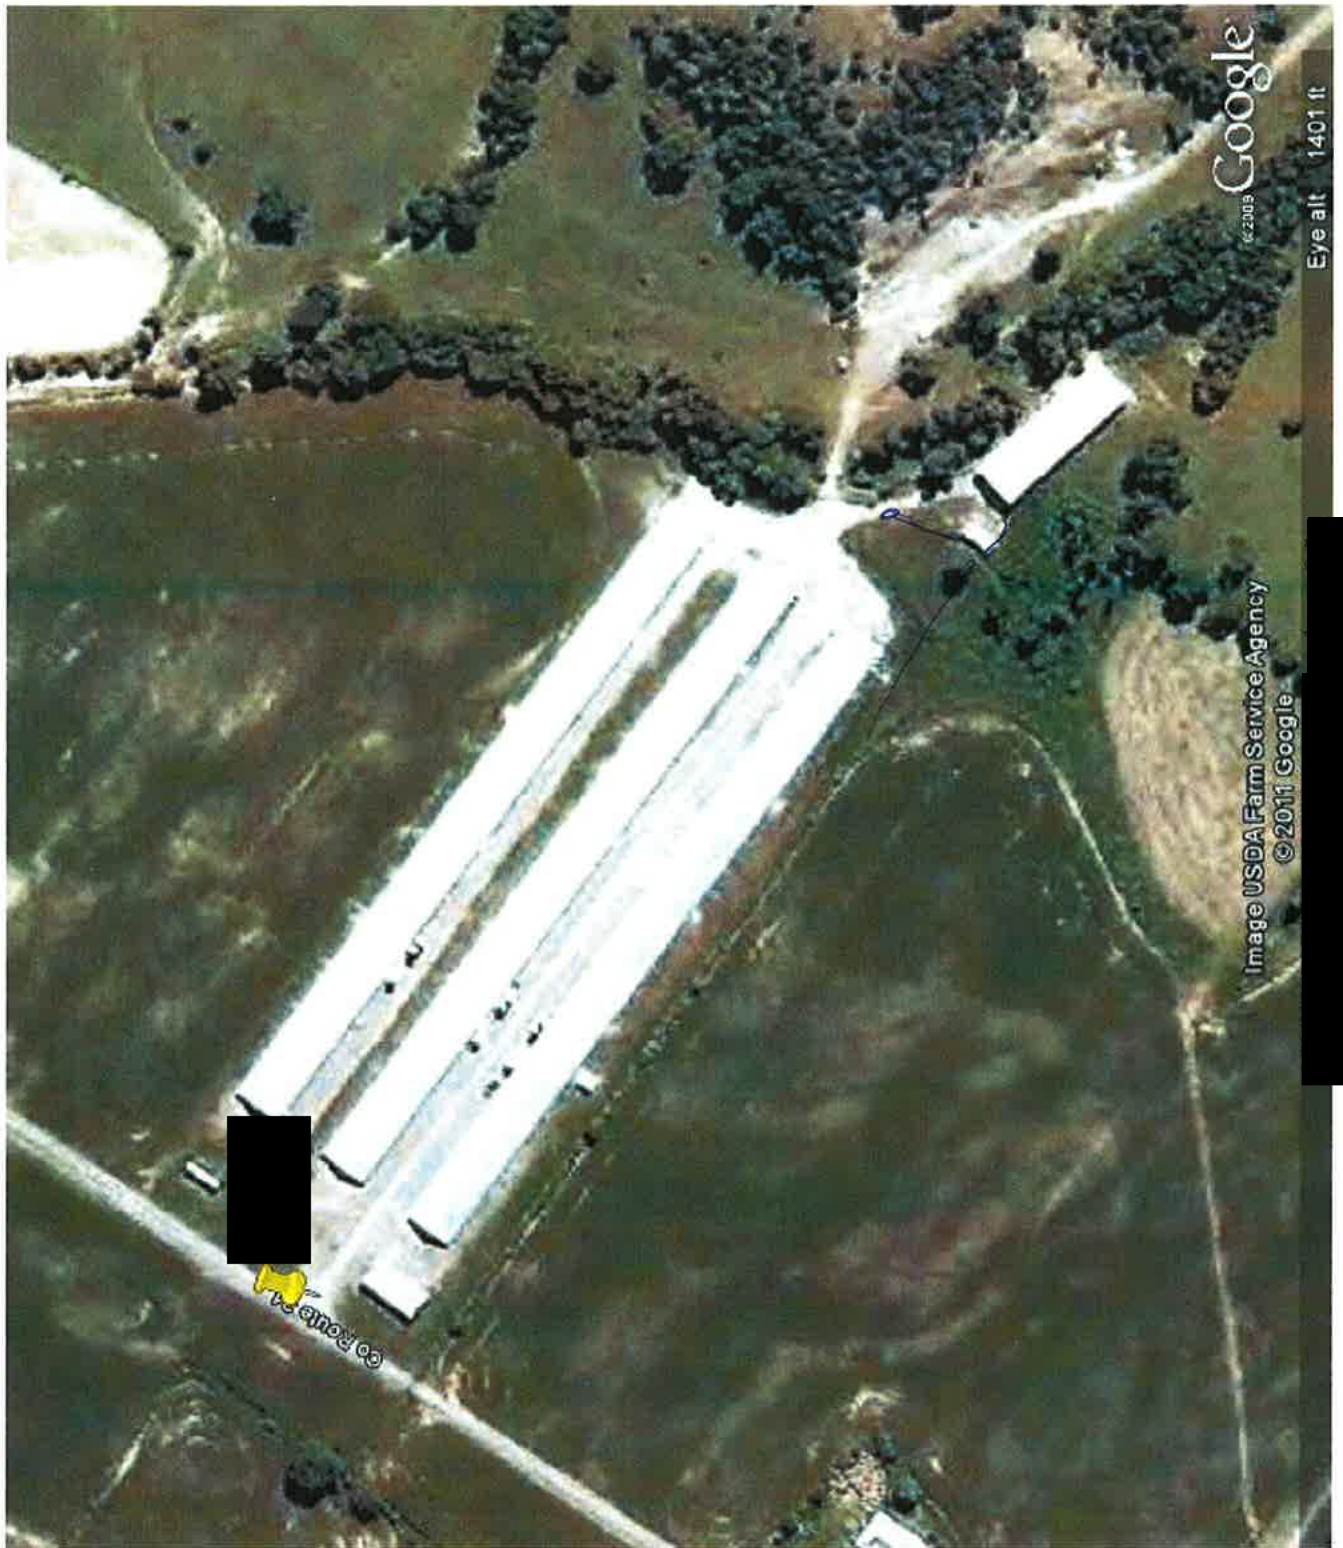
Site Map 1

From interpolation of satellite imagery from Google Earth, the coordinates at the entrance (nearest to Poultry House 554) to the Facility are [REDACTED] and indicated by the yellow thumb tack on Site Map 1. The Facility is owned and operated by Mr. [REDACTED]. Mr. [REDACTED] has four full-time and one part-time employee. The poultry operation is just a part of his business that also includes the raising of crops and beef cattle. At this Facility, Mr. [REDACTED] raises turkeys under contract with [REDACTED] and has for the last seven years. The lane sign refers to "[REDACTED]". The Facility consists of three poultry houses and one manure shed. The poultry houses are referred to as Houses 551, 554, and 720 with House 551 being at the left of the property and House 720 being right of the property (see Site Map 2). Houses 551 and 554 were built in 1987, with 100 feet added in 1990 and 1992, respectively. House 720 was built in 1990. Houses 551, 554, and 772 are 50' x 772' and house approximately 8,100 birds each per flock. Two flocks may be present at the same time for a total of 48,600 birds for at least 6 weeks or more. Manure is land applied to cropland. Mr. [REDACTED] had 1352 acres which he owns and an additional 400 acres of rented land available. Commercial fertilizer is used in addition to the manure. No biosolids or manure imported from other farms is land applied. Mr. [REDACTED] maintains an NMP which is amended yearly and was currently being revised.

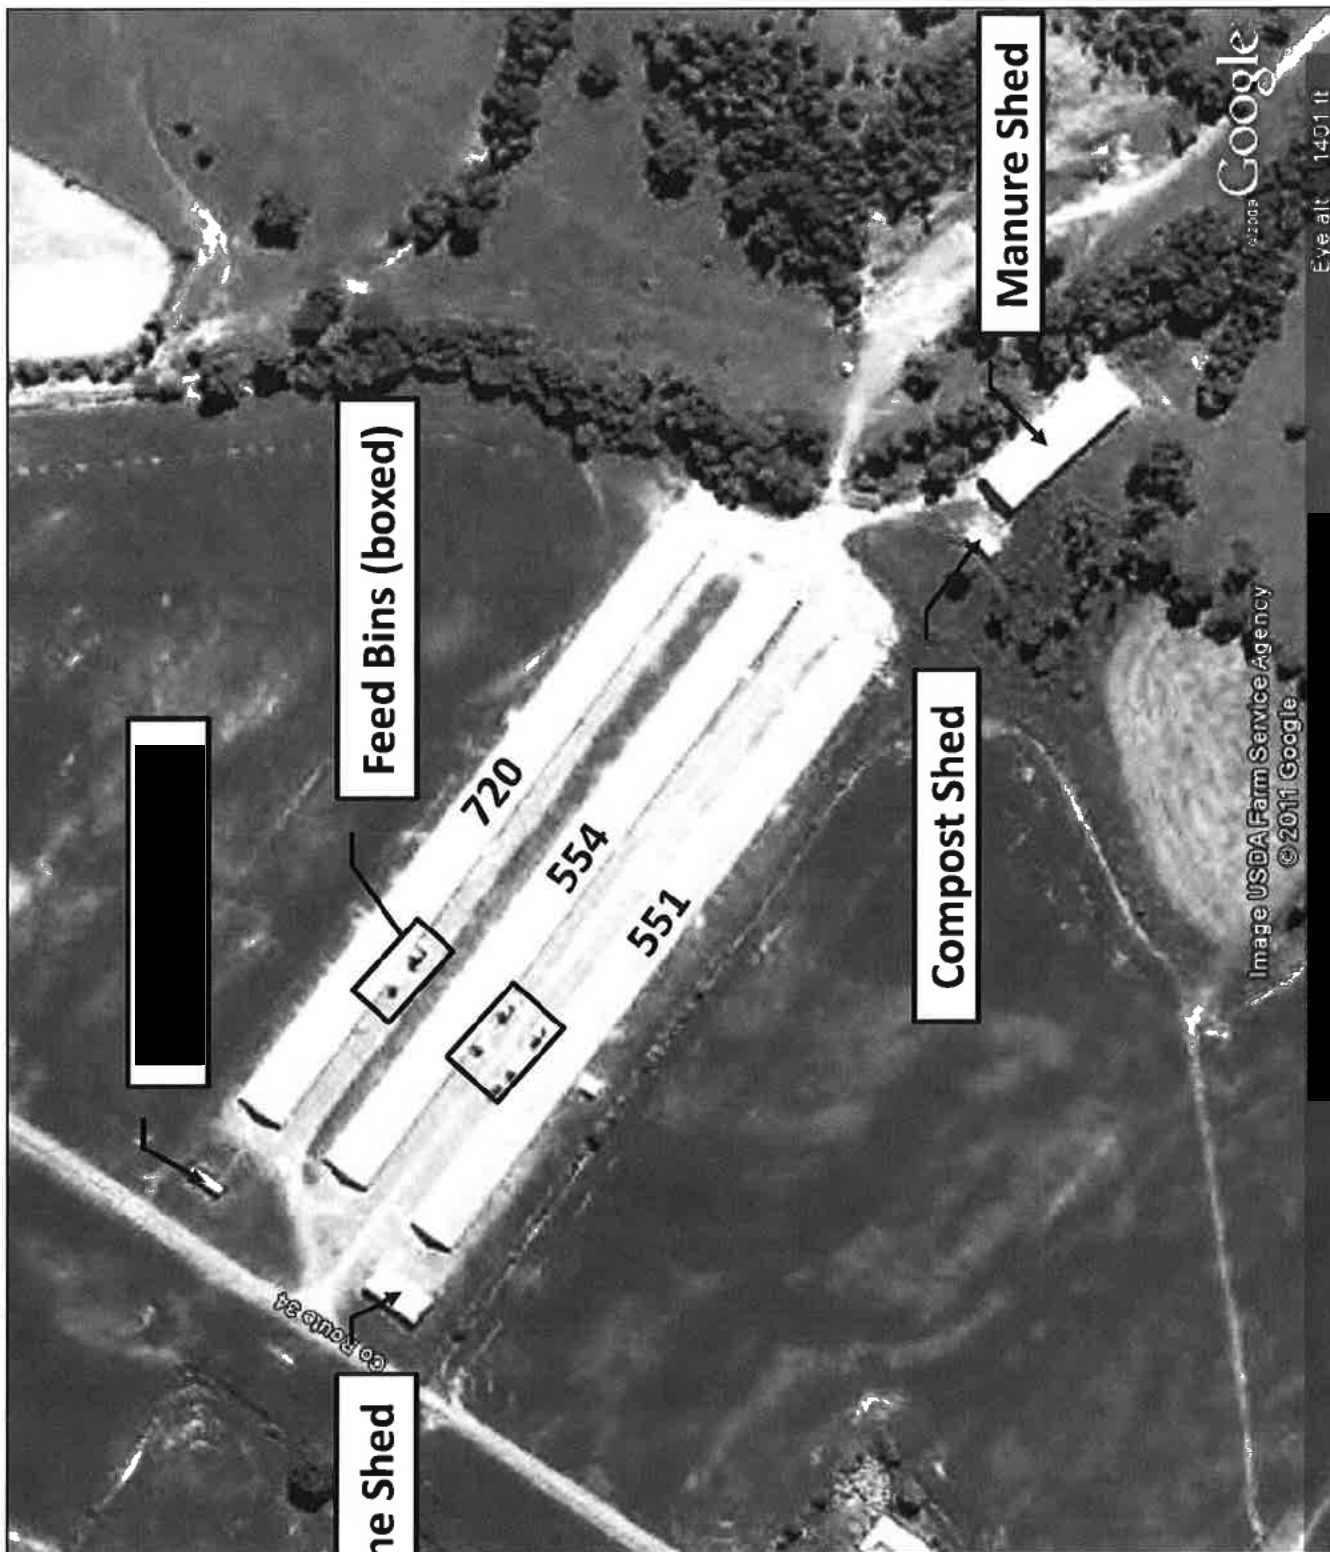
Site Map 2

There is a manure shed on-site (see Site Map 2). Manure is placed only in the manure shed and is never stockpiled. A crust-out is done between flocks. However, every 18 months a total clean-out is performed based upon the affordability of litter. Timing for total clean-outs is decided by a management team appointed by the Board of Directors of [REDACTED]. Cleaning of the poultry houses is done using a manure spreader and a Bobcat front loader. The concrete pads are routinely cleaned of any spilt manure using a shovel. The area between the manure shed and compost shed is dirt (i.e. no concrete pad). Manure was observed on the ground between the manure shed and compost shed.

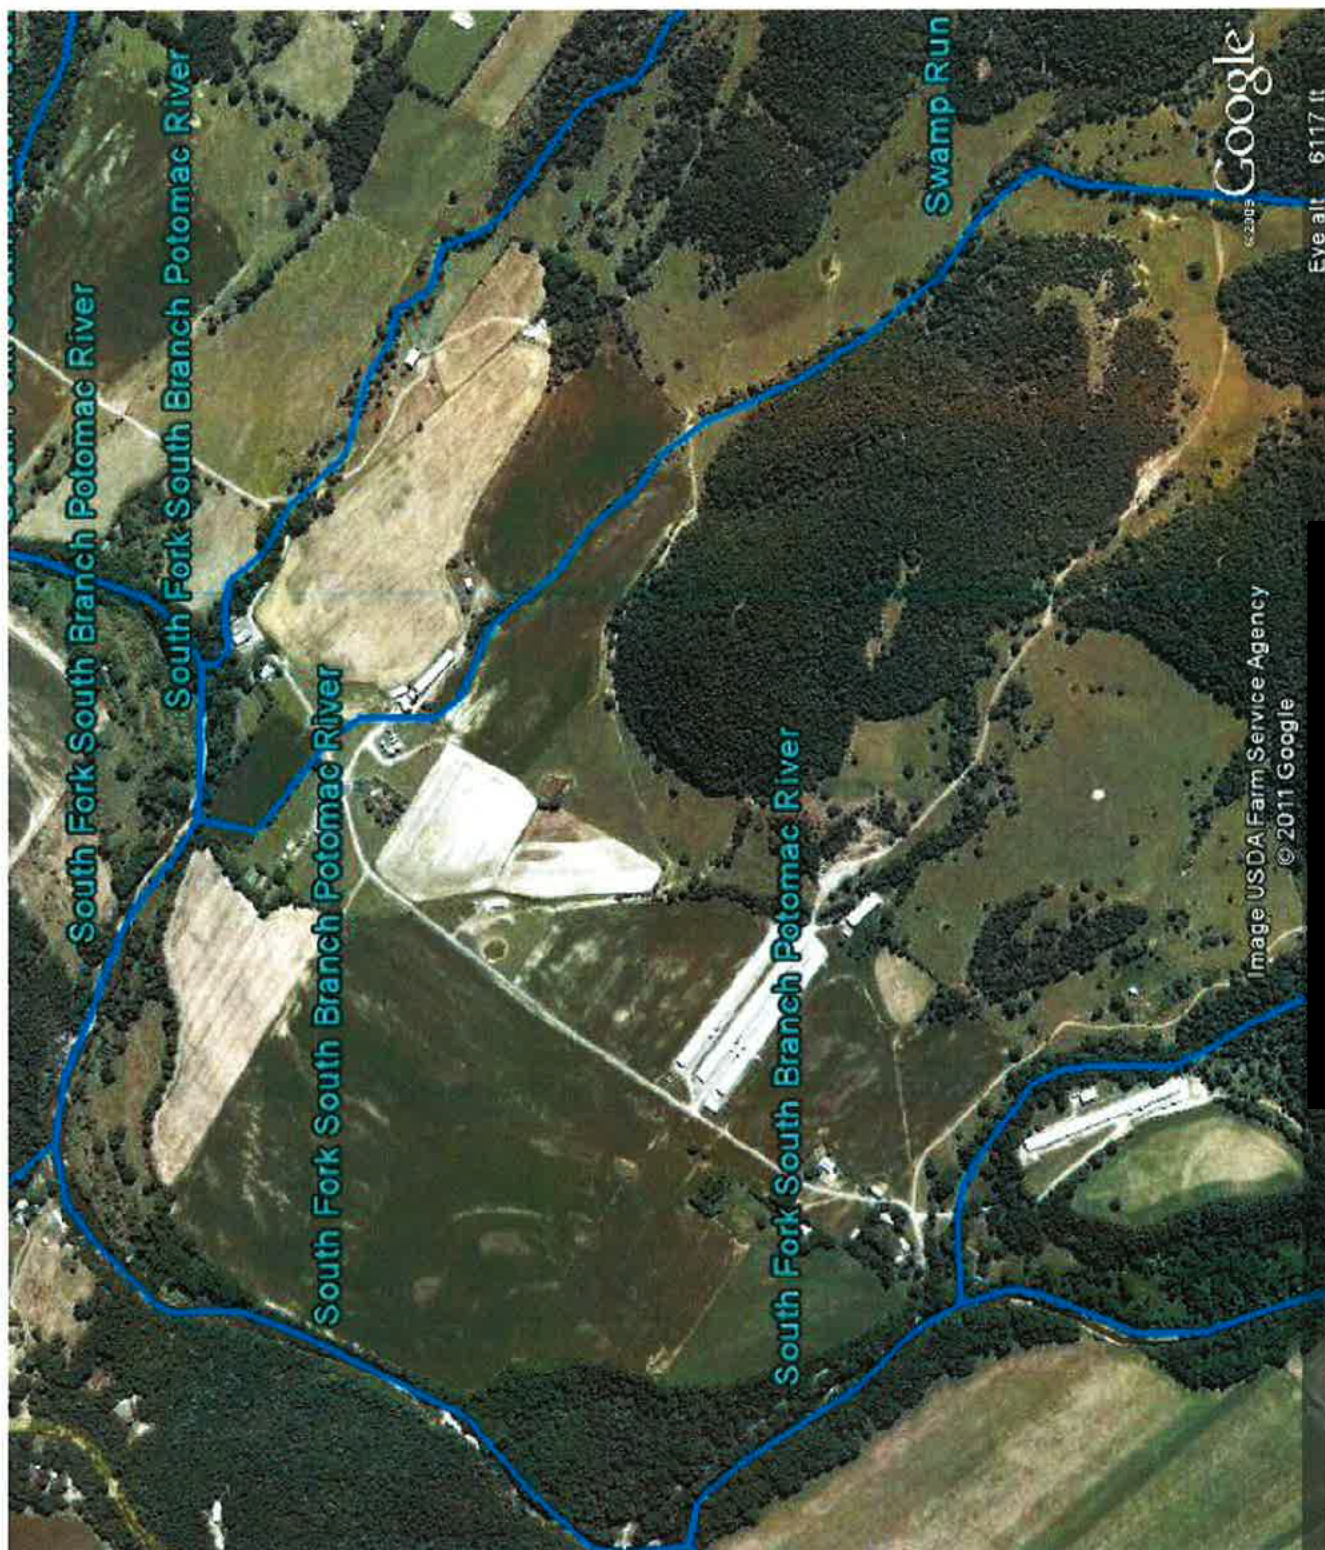
Site Map 3

None of the poultry houses have gutters with down spouts. A stream was observed to the east of the poultry houses, but this stream was not mapped in the National Hydrography Dataset (see Site Map 3) but was mapped on the USGS topographic maps (see the "Additional Information Gathering" Section of this report). The site of the three poultry houses crosses a natural watershed boundary; however, excavation and grading to build the poultry operations may have altered natural drainage. The western ends of the house (nearest to [REDACTED] Road) appear to drain toward [REDACTED]. A grass swale along a majority of House 551 also drains toward [REDACTED] but no ditches were observed beyond [REDACTED] Road. There was a ditch at the east end of House 551 with stagnant water. Based on natural drainage, this ditch drains towards the compost shed.

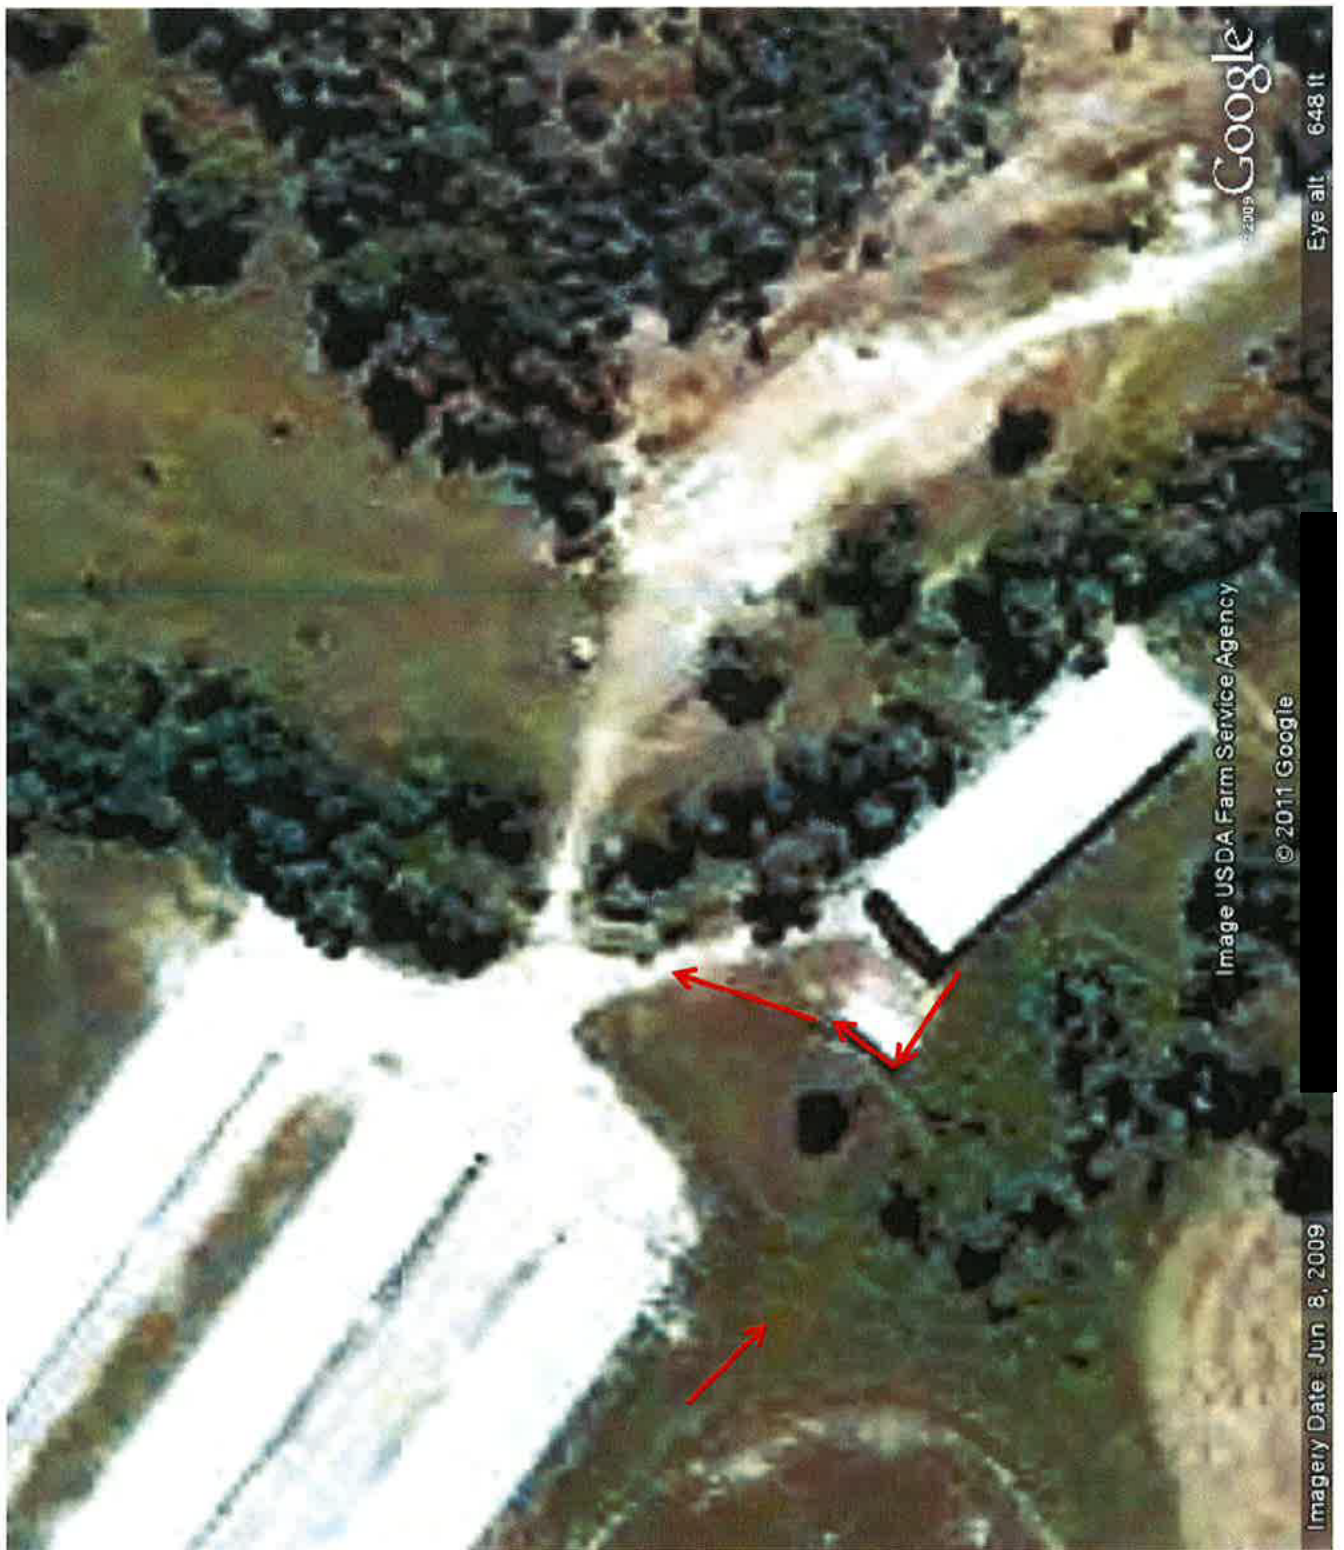
Site Map 4

The areas between Houses 551 and 554 and Houses 554 and 720 are fairly flat with low spots where ponded stormwater still was visible. It is unclear the point at which water drains to the east drains to the Unnamed Tributary of Swamp Run and to the west toward [REDACTED]. A majority of the stormwater runoff from the northern side of House 720 flows into nearby pasture fields used for crop production. The Facility also had a man-made ditch (see Site Map 3) surrounding the composting shed and along the southern side the Manure Shed. The ditch leads to a culvert under the access lane from the poultry houses to the manure and compost shed. The flow then enters a stream that according to Mr. [REDACTED] was called Swamp Run. However, based on the USGS topographic maps, this stream is an Unnamed Tributary of Swamp Run. The approximate locations are indicated on Site Map 4.
